Upper Limit Switch Failure:

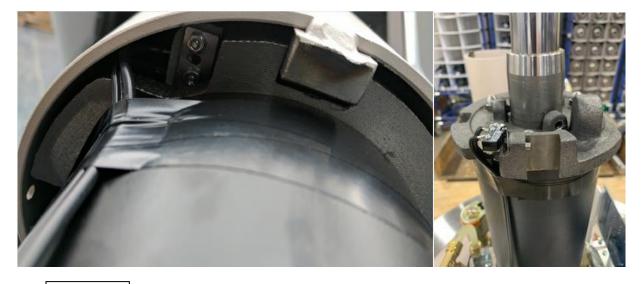
Diagram 1

Upper Limit Switch Purpose: The upper limit switch is located on the top of the lift of all Reliance chairs (Diagram 1) in the back or base motor of chair. When fully assembled hidden by the keyshield (Diagram 2). The switch is wired normally open but held close by a pin that pushes against the switch. When the chair base reaches full elevation a notch releases the pin, opens the switch and turns off the base motor.

Issue: When trying to raise the chair from any control point, the base will not raise. There is clicking coming from the board.

Cause: Limit switch is out of adjustment, not closing the limit switch. As a result no signal is being sent to the board to tell the chair to raise.
